INTERNATIONAL CONFERENCE ON GEOMEMBRANES

**Proceedings
Volume I**

**June 20–24, 1984
Denver, Colorado
USA**

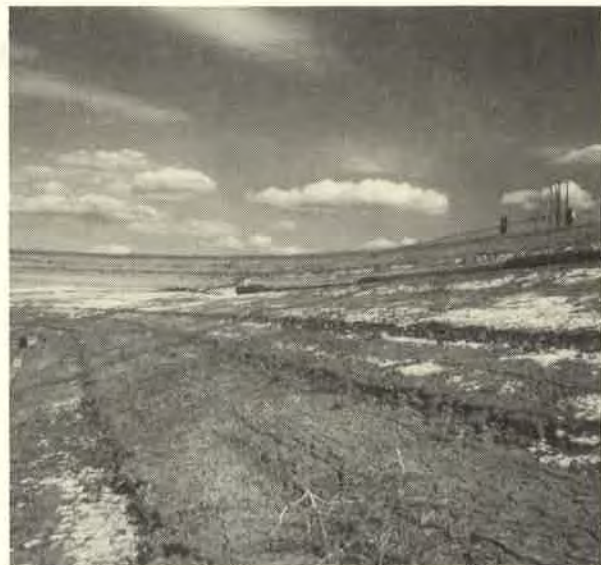
Figure 2: View of pond in southeast corner. Note the wave-cut benches illustrating different pond levels, and desiccation of surficial clay.

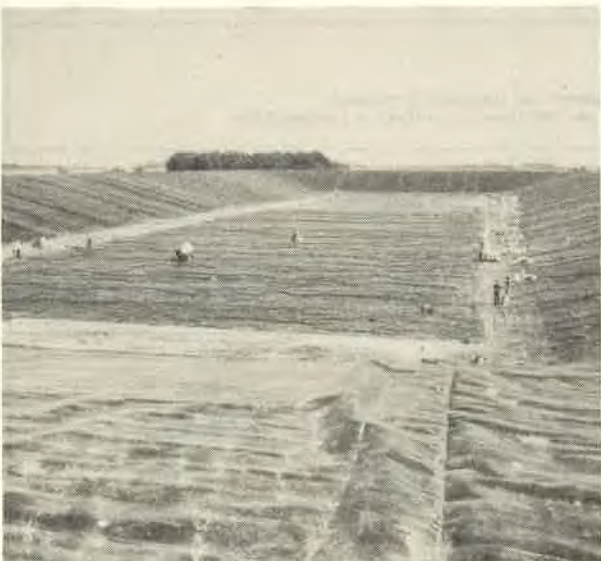
Figure 6: In-place high density polyethylene (HDPE) liner.

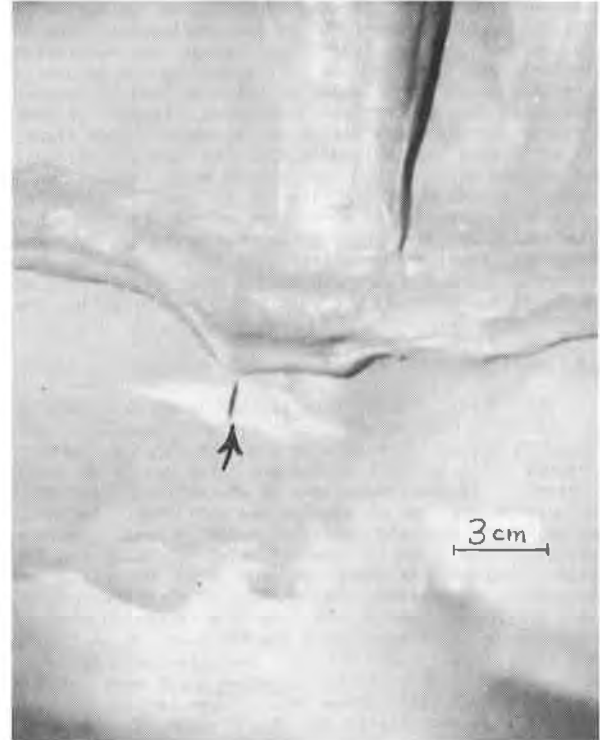
Fig. 2. The white "moustache" shaped area near the center of the underwater photograph is yielded HDPE. The arrow points at a vertical slit hole in the HDPE geomembrane, (Problem 1).
