# **GEOSYNTHETICS '91**

## **CONFERENCE PROCEEDINGS**

**Radisson Hotel  
Atlanta, Georgia, U.S.A.  
February 26-28, 1991**

**Volume 1**

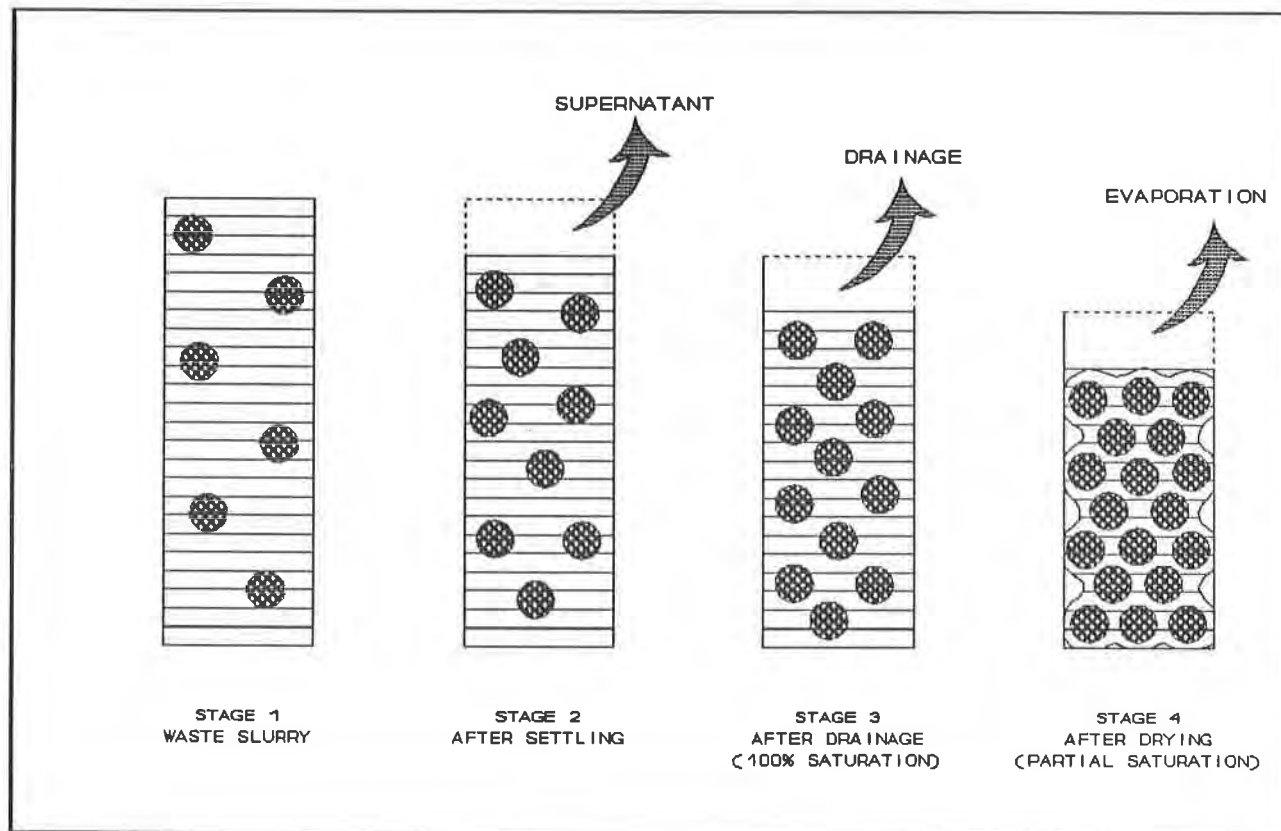
Figure 3  
State of Solids During Deposition and Consolidation

Stage 2 begins where the slurry has been initially deposited in a super-saturated plastic condition under water. As the solid particles settle, low intergranular contact is established and bleeding of surface water has started, with further release of liquid induced by drainage and/or evaporation. Loading of the settled deposit will result in formation of excess pore pressures which will slowly dissipate with seepage.

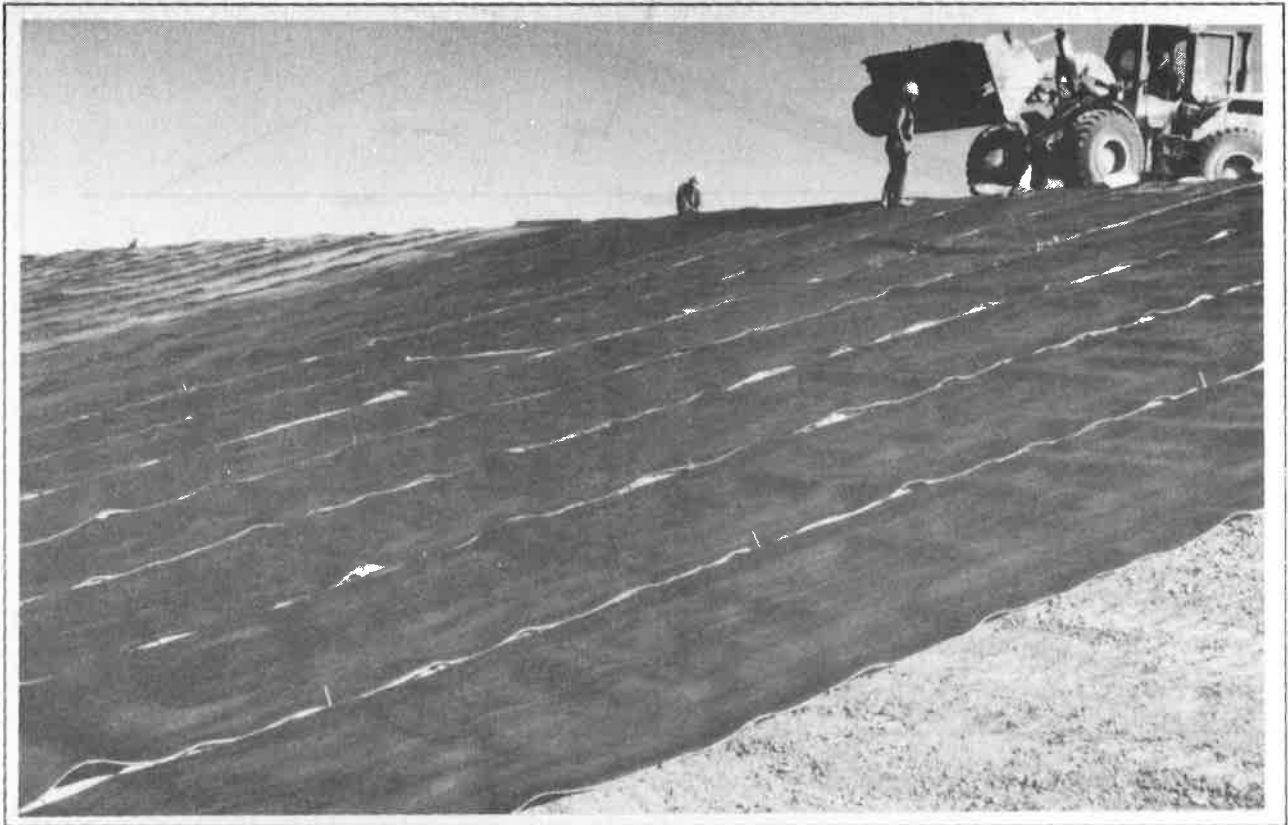
**Figure 9**  
**Construction of the Geonet Decant**

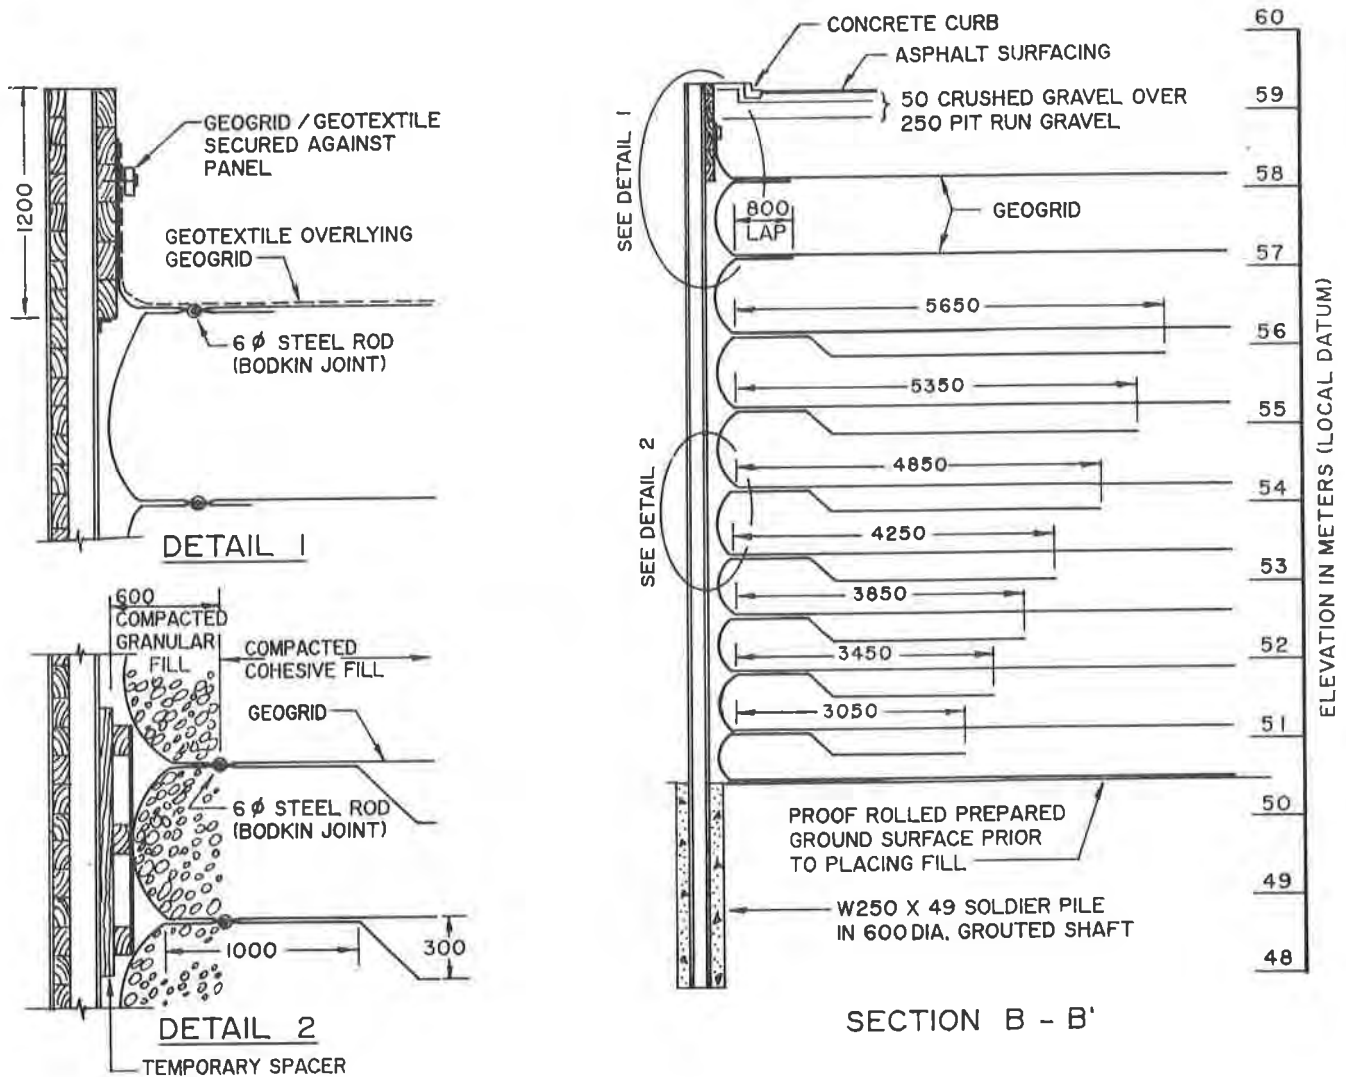
Figure 3 Typical section and design details
