Geosynthetics '99

"Specifying Geosynthetics and
Developing Design Details"

Conference Proceedings

LESSONS LEARNED FROM FAILURES ASSOCIATED WITH GEOSYNTHETICS

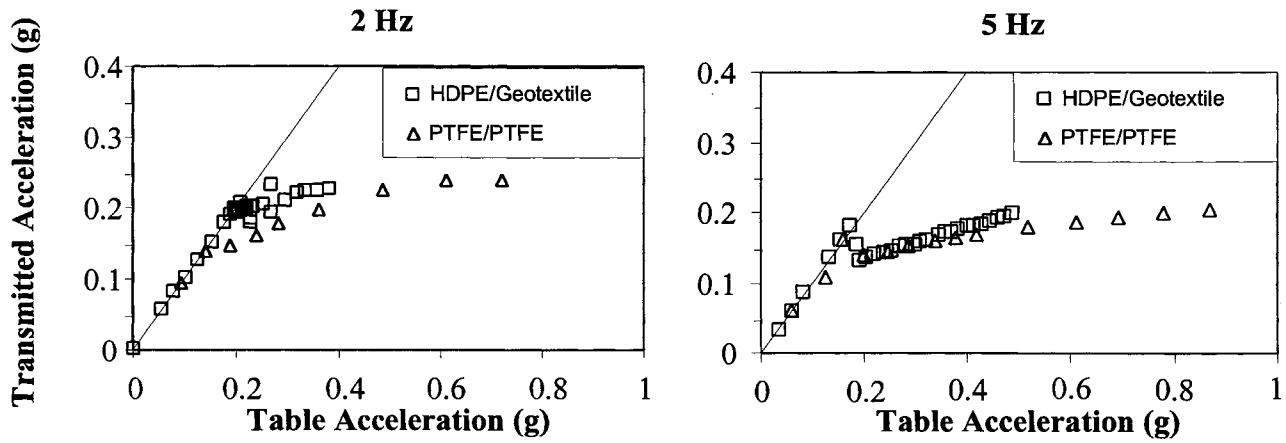
Figure 5. Accelerations transmitted through geosynthetic interfaces tested at 2 and 5 Hz sinusoidal table excitations.

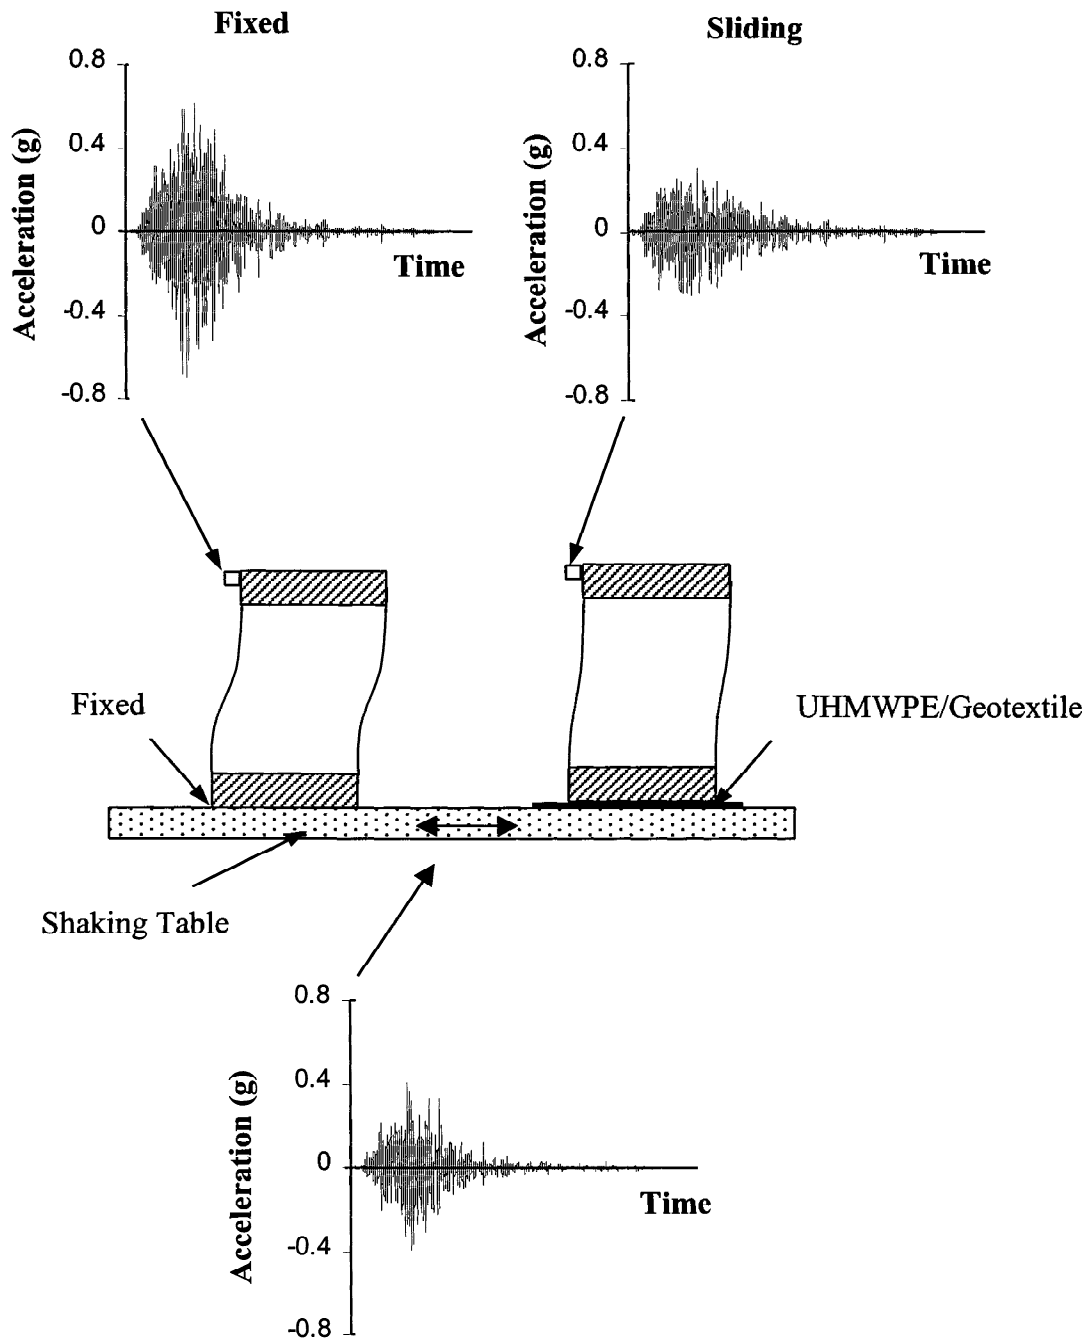
Figure 11. Comparison of model responses with and without geosynthetic foundation isolation.

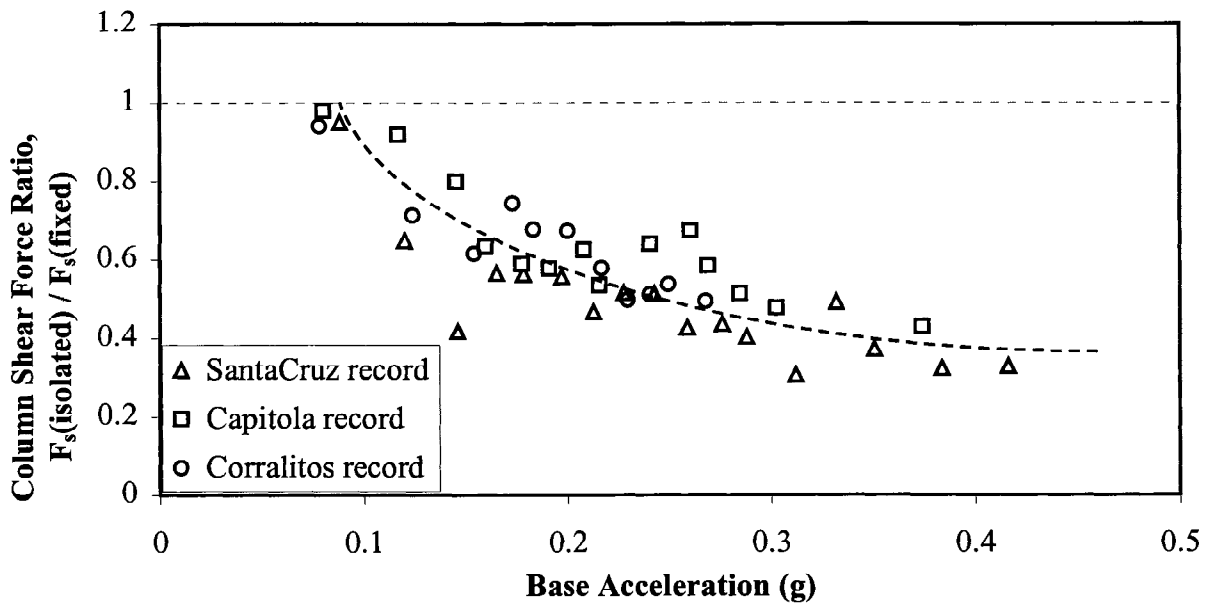
Figure 12. Reduction in column shear forces due to geosynthetic foundation isolation as a function of ground accelerations.

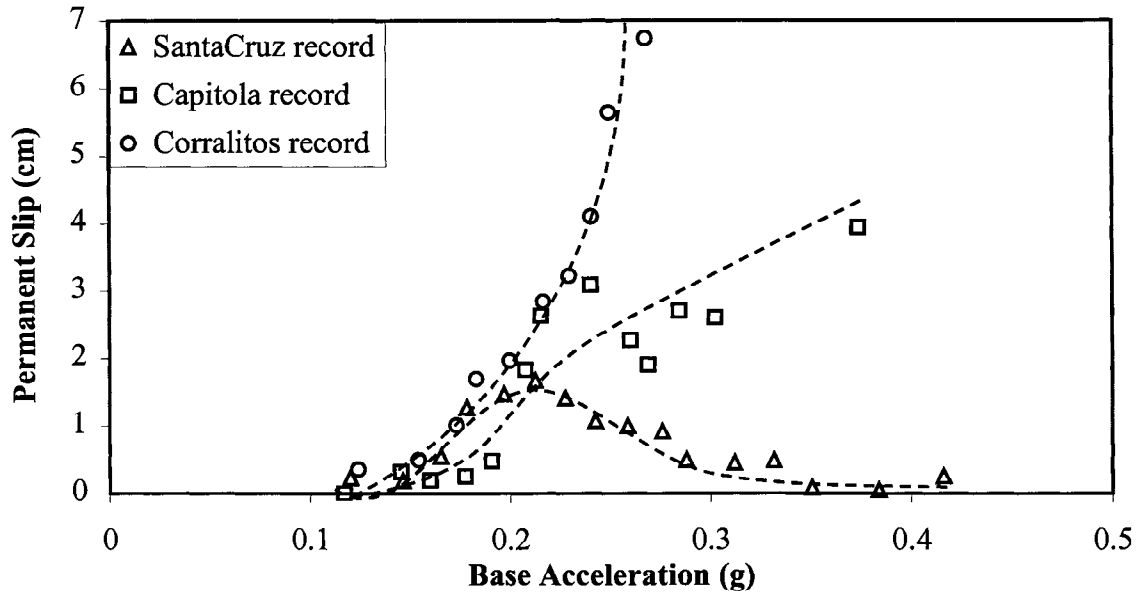
Figure 13. Slip deformations of the base as a function of ground accelerations.

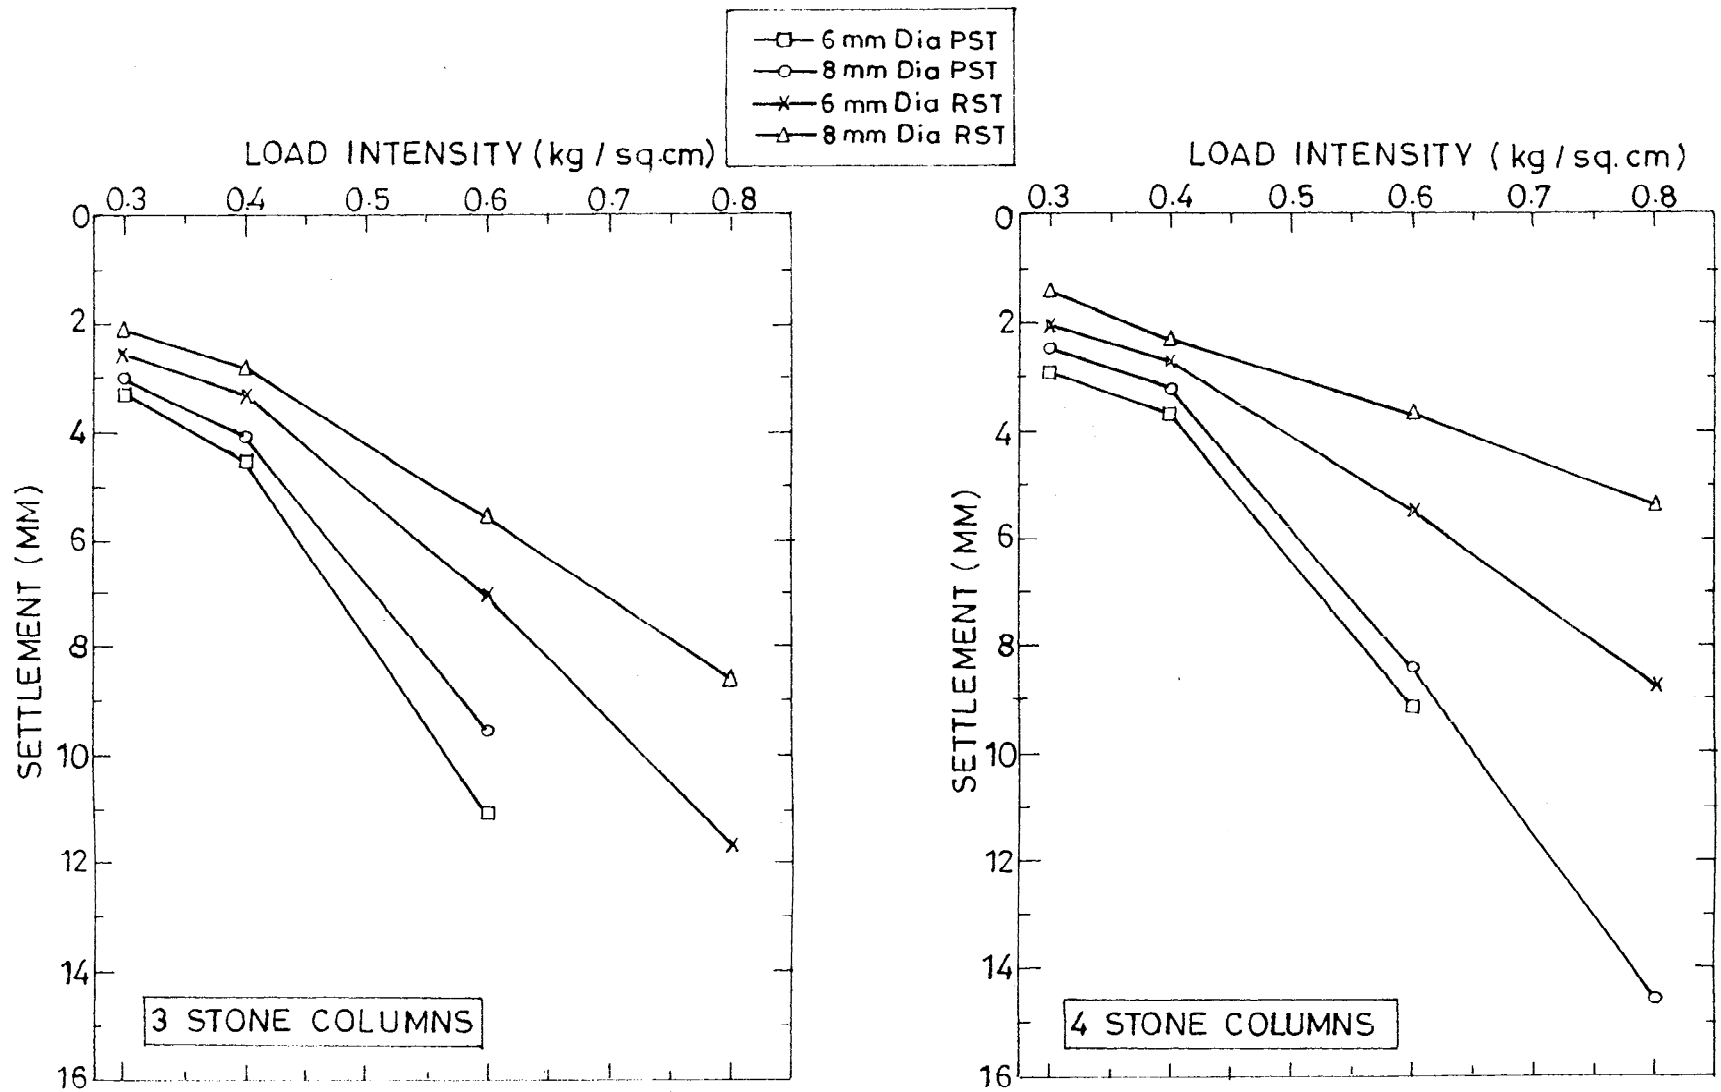
FIG. 2 Load settlement curves for plane stone columns (PST) & reinforced stone columns (RST)

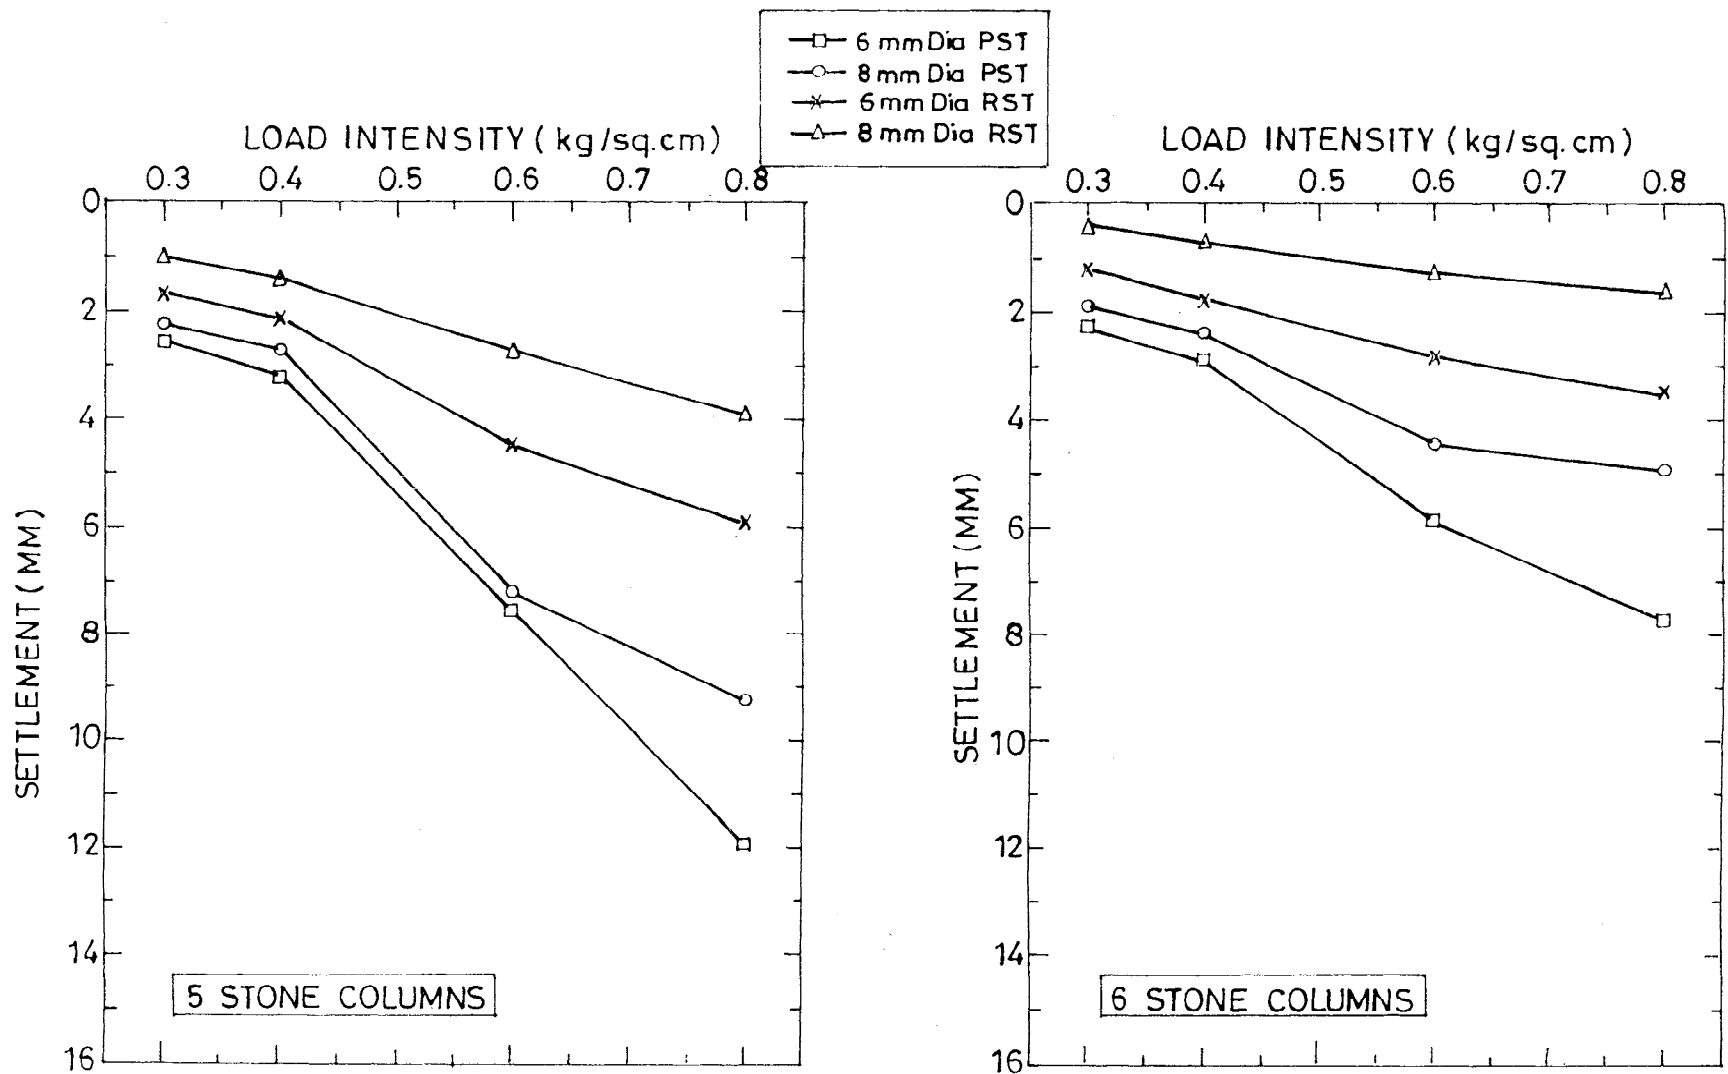
FIG.3. Load settlement curves for plane stone columns (PST) & reinforced stone columns (RST)

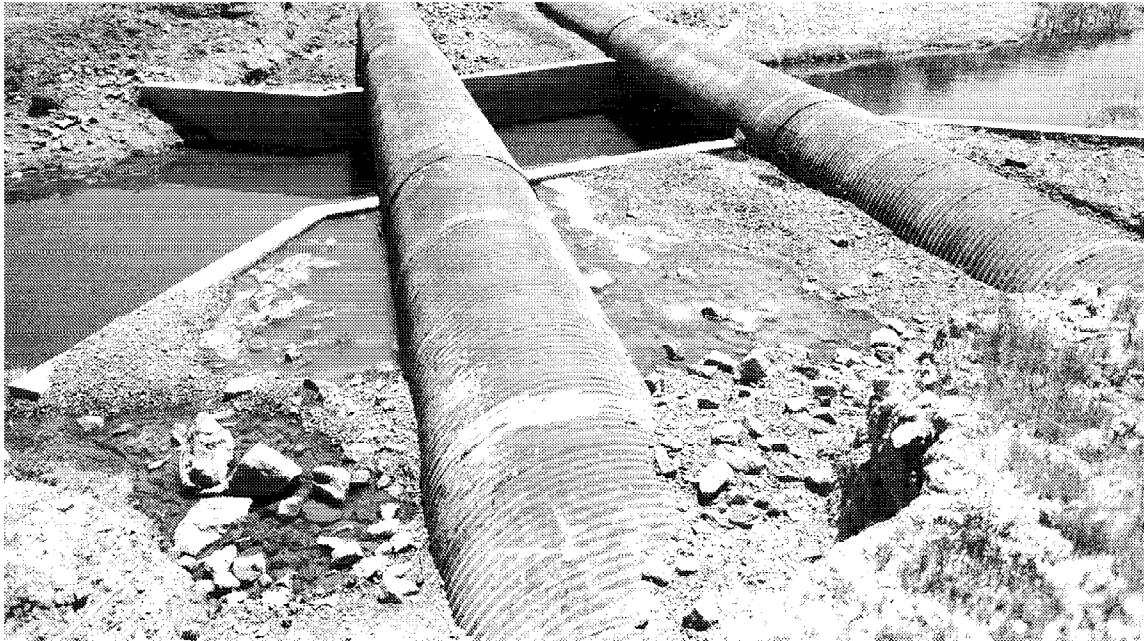
Figure 4. Pipe Bridge and Retaining Walls

granular bedding. The footings for the retaining walls were designed to be 1.2 m wide, 0.3 m thick, constructed of reinforced concrete, and to have a bearing elevation of 98.3 m. The 2.7 m high walls were 7.6 m long with 3.7 m long wingwalls oriented back at 45 degrees. The culverts were designed to be supported on saddles cast into the concrete. The pipes penetrate through the wall at a skew of 10 to 15 degrees. The remainder of the pipe sections were designed to be supported over unreinforced granular bedding. Figure 4 shows the pipe bridge and retaining walls.

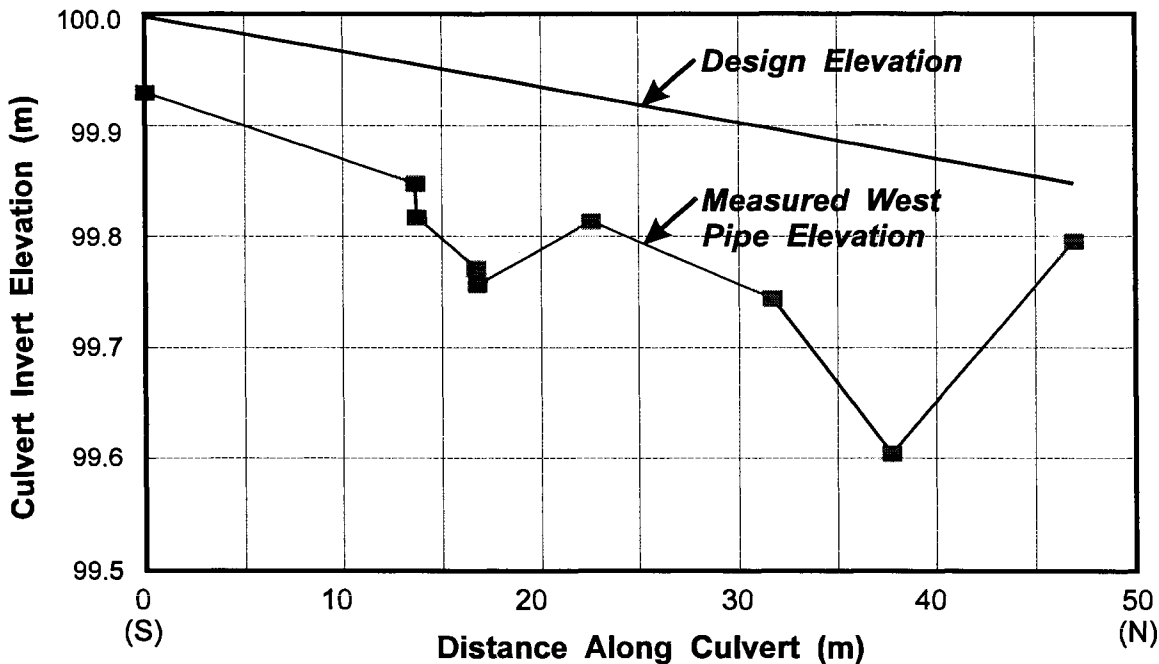
Figure 8. Design and Actual Invert Elevations

During this visit, water was flowing very slowly along the bottom of the pipes. The author noticed that the water depth varied significantly as it flowed through the pipe, and that the water depths could be used to measure the profile along the pipe invert. The design pipe invert profile and the pipe invert profiles measured 8 months after construction are compared on Figure 8. The survey data and water depth data indicate that the pipe inverts, when compared at the north and south ends, approximately maintained the 150 mm elevation drop from south to north as designed even though the actual pipe ends have settled. The wall settlement and ends of the exposed west pipe where the pipe bridge had been removed indicate that this design gradient was also maintained at the pipe bridge location. However, assuming that the pipe had been laid with a smooth invert, the water depths along the pipes indicate that significant (120 to 270 mm) differential settlements occurred in the middle of the berms. Abrupt water depth changes as great as 100 mm were measured across pipe joints indicating that pipes had moved vertically with respect to each other.

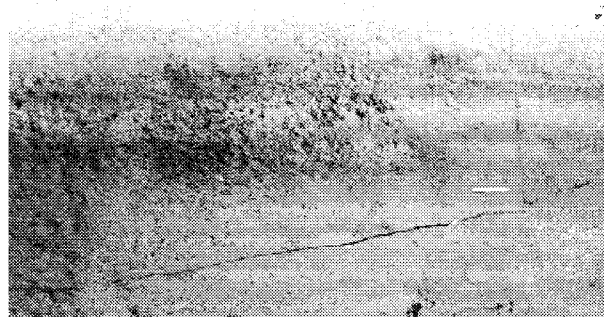
Figure 23- Contraction cracks in side walls

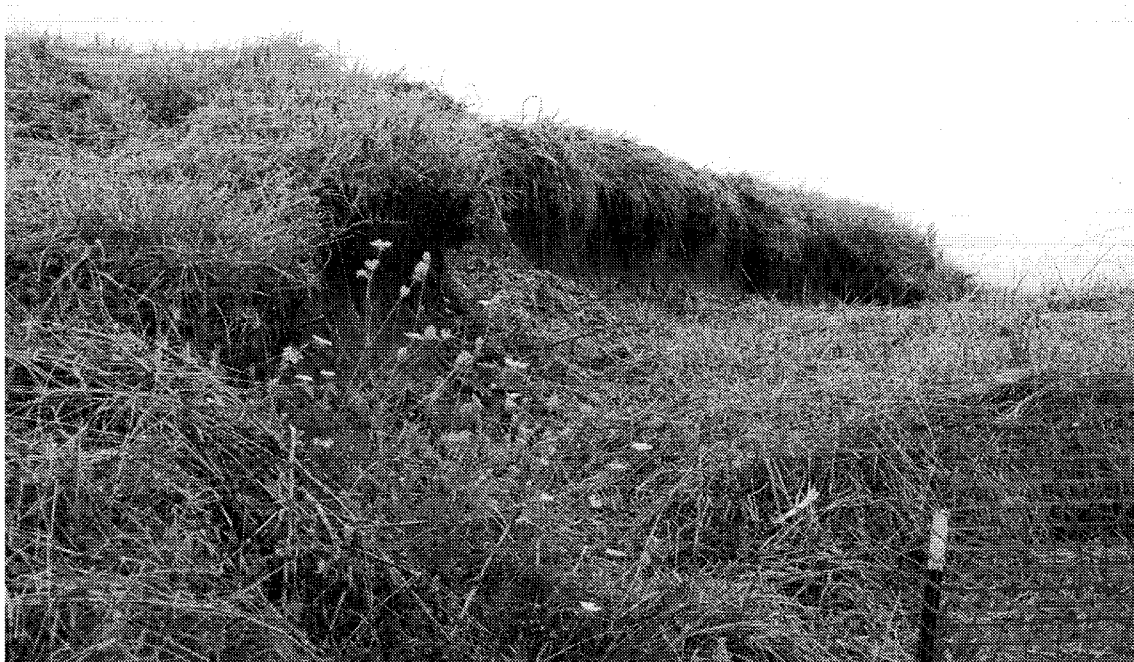
Figure 5. Serious Surface Cracking Prior to Repairs

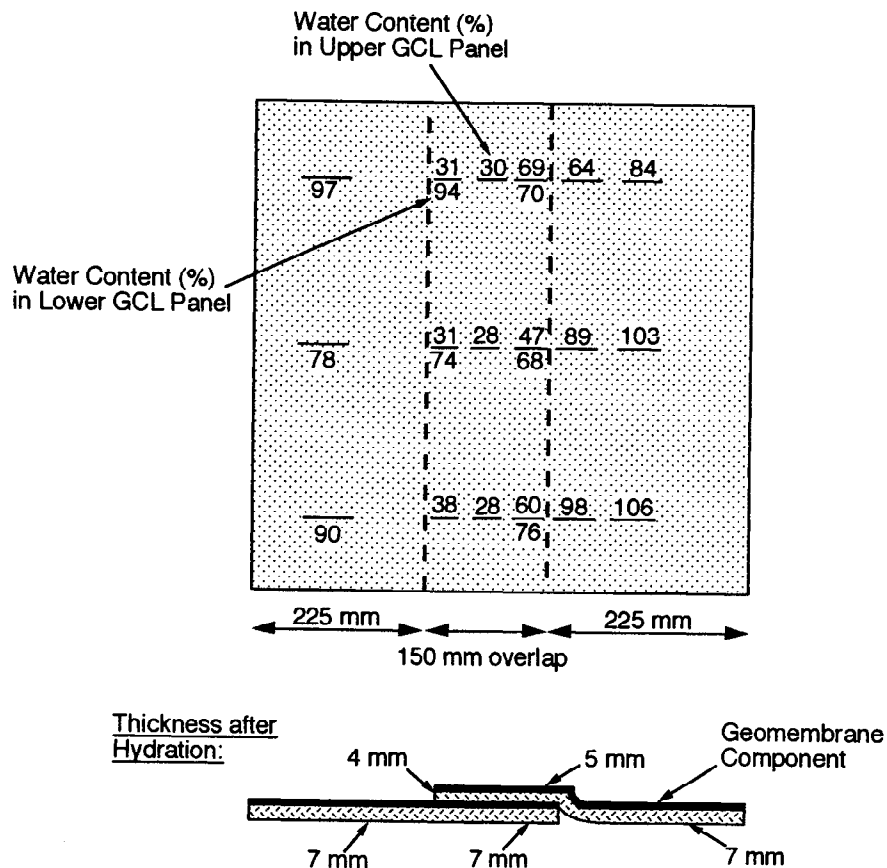
Figure 6. Water Contents in Bentonite Component of Geomembrane-Supported GCL after Nine Weeks of Exposure to Underlying Sand Having a Water Content of 8%.

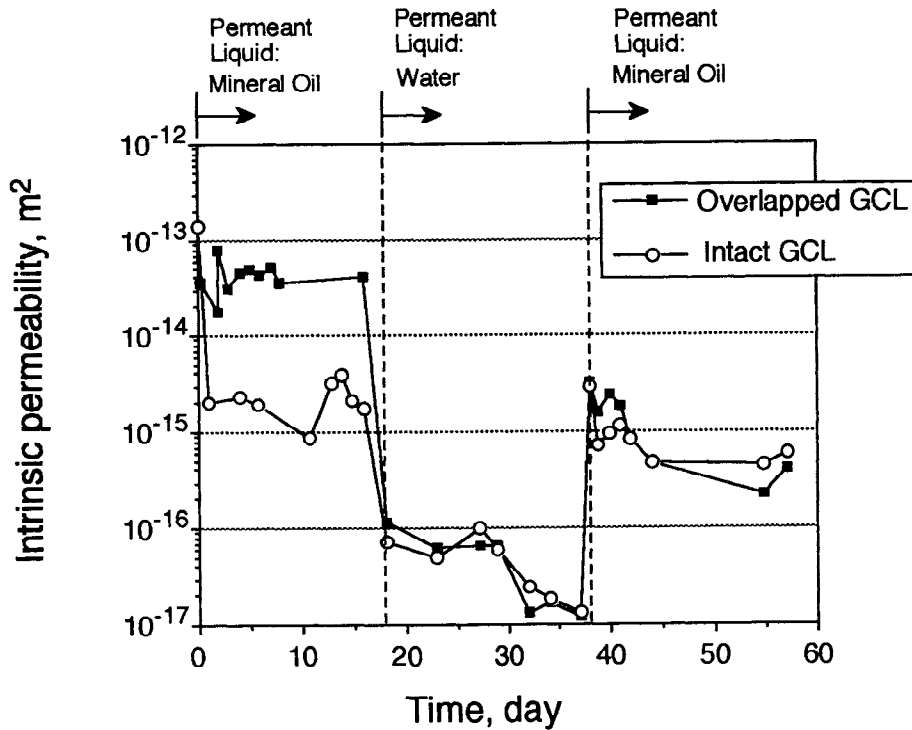
Figure 9. Intrinsic Permeability of Geotextile-Encased GCL that was Hydrated by Subgrade Moisture, Permeated with Oil, then Permeated with Water, and Finally Re-Permeated with Oil.

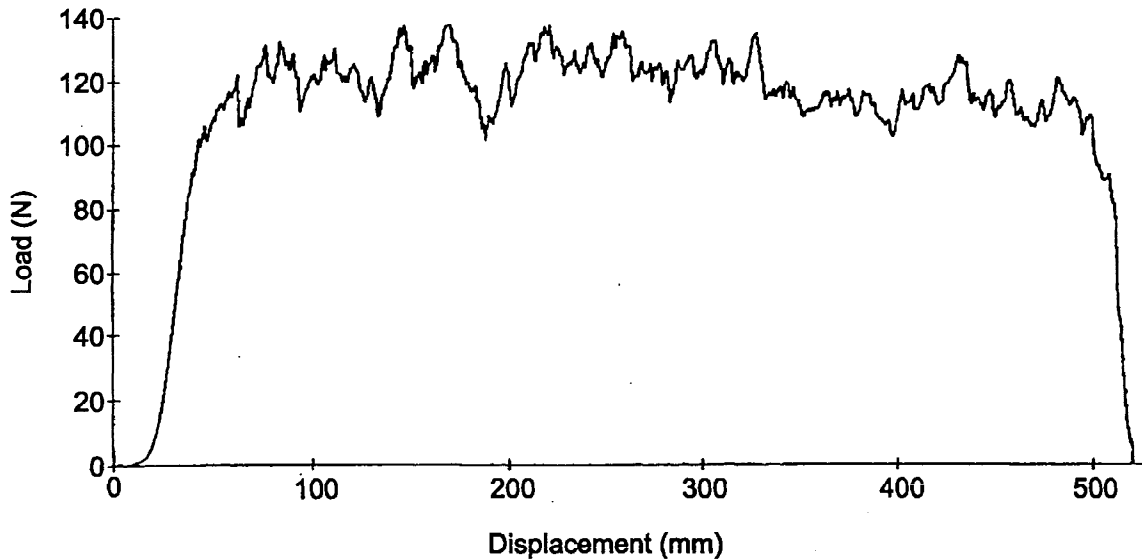
Figure 4. Typical Peel Test Results for a Needle-Punched GCL

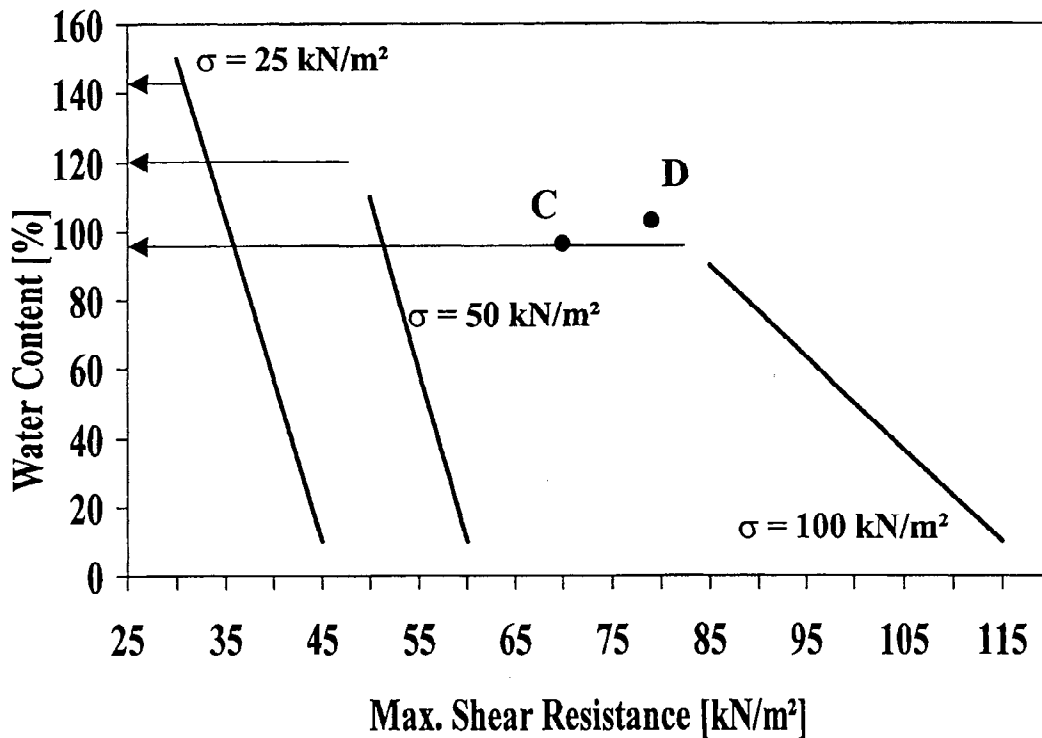
Figure 7. GCL Shear Resistance with a Peel Value of 78 N/10 cm at Different Water Contents
